# 2022 INVESTIGATION INTO RANDOM FOAMING EVENTS AT AREA Q PUMPING STATION, BELL BLOCK, NEW PLYMOUTH

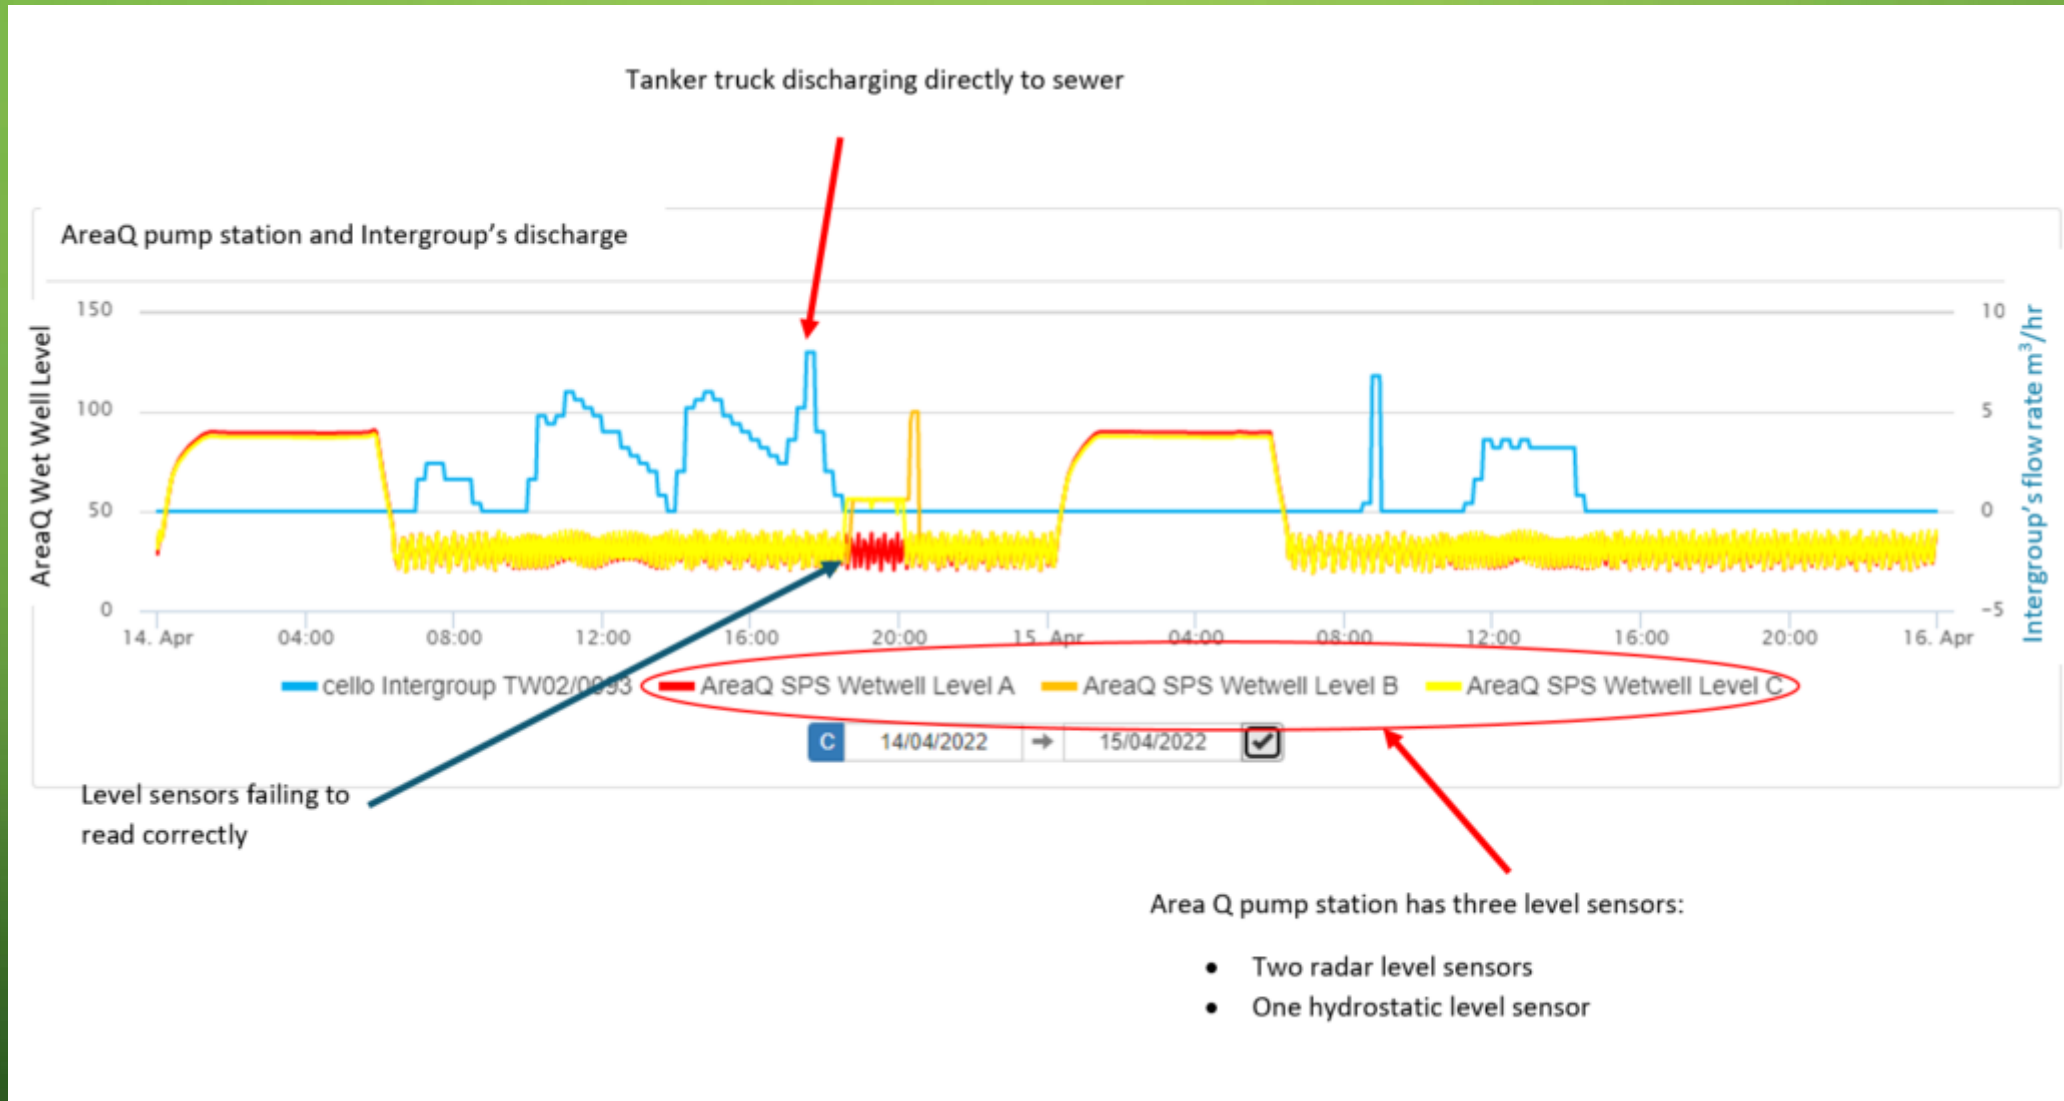
# INTERGROUP'S FLOW DATA VS AREA Q PS FOAMING

- Rig sites now label the various tanks as Grey water or Black water.
- Intergroup recommenced discharging Black water in their yard to sewer.
- Several days later foaming reappeared at Area Q pump station. Data showed this continued to happen right after Intergroup's Blackwater discharge.
- At this point it was suspected that some other discharge was the cause of the foam and when Intergroup discharged through their system the higher flow combined with the product already in the pipe caused the foaming.

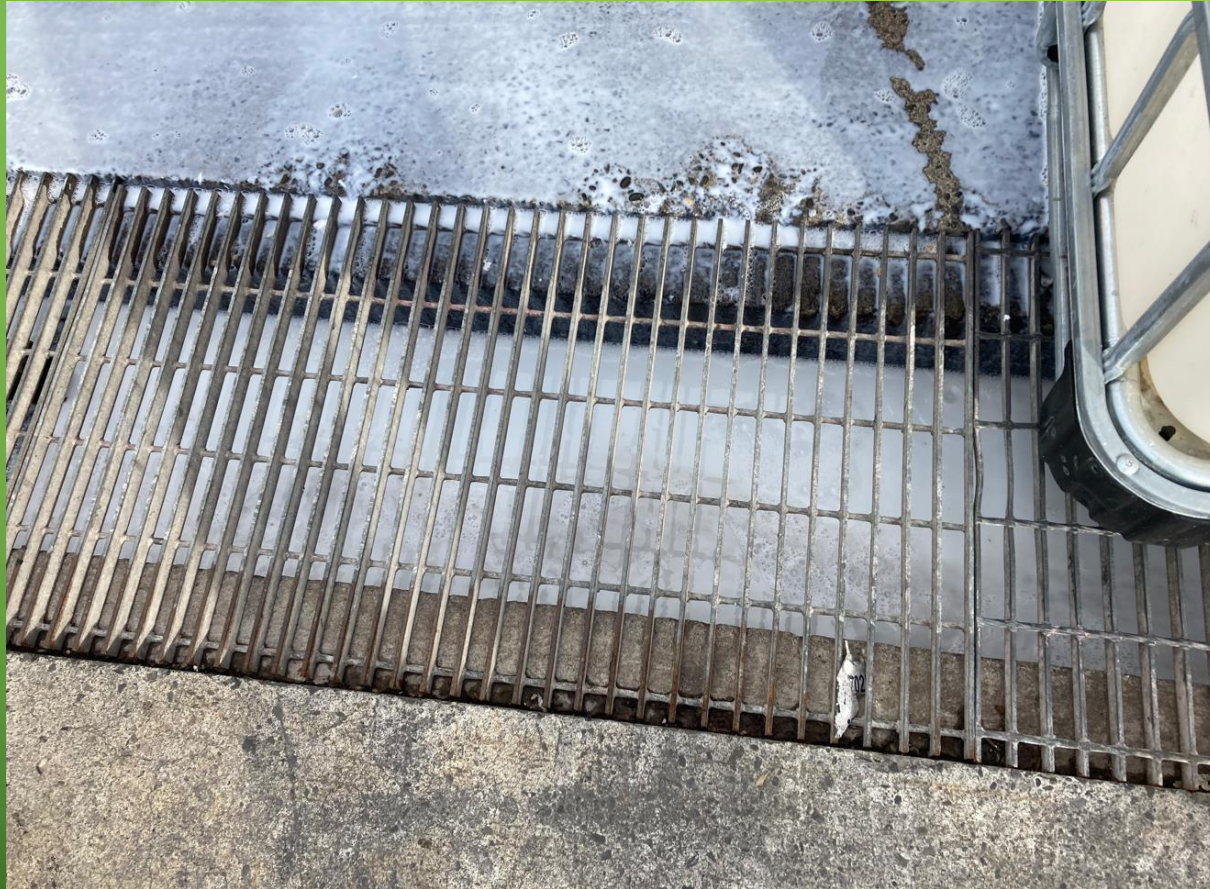
Slot drain bordering the wash pad

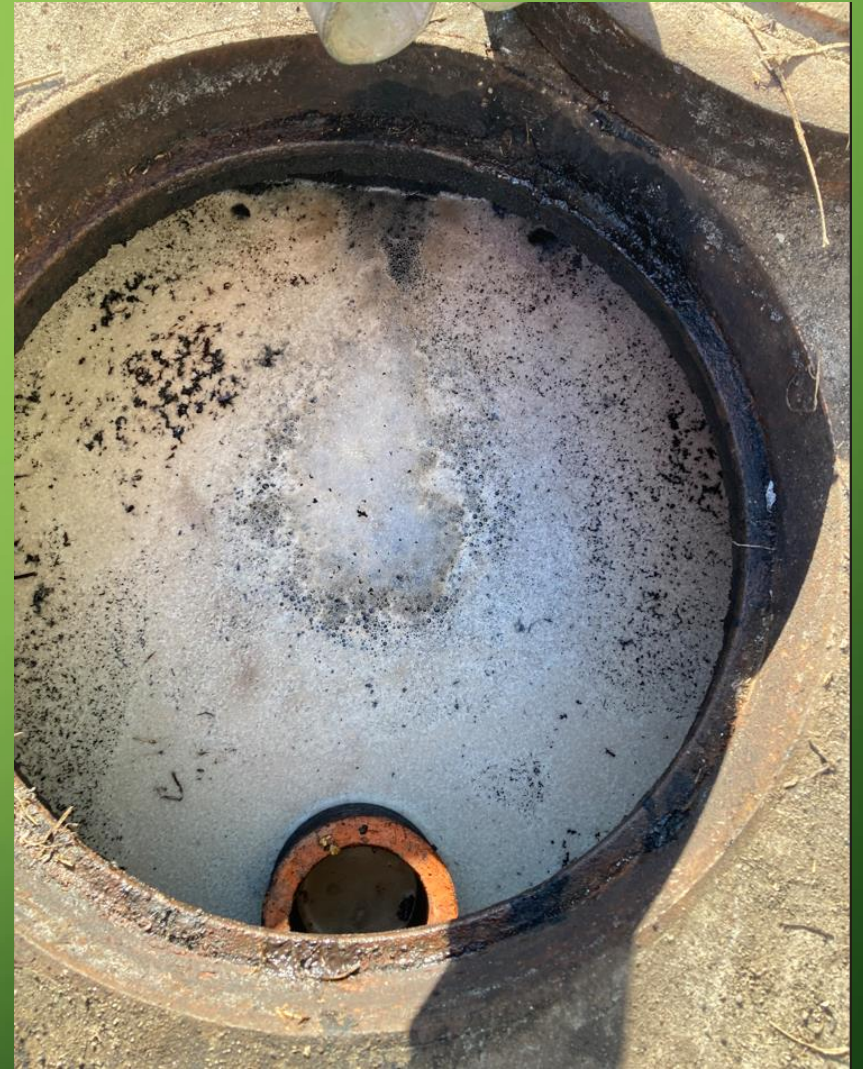
Third stage of oil interceptor

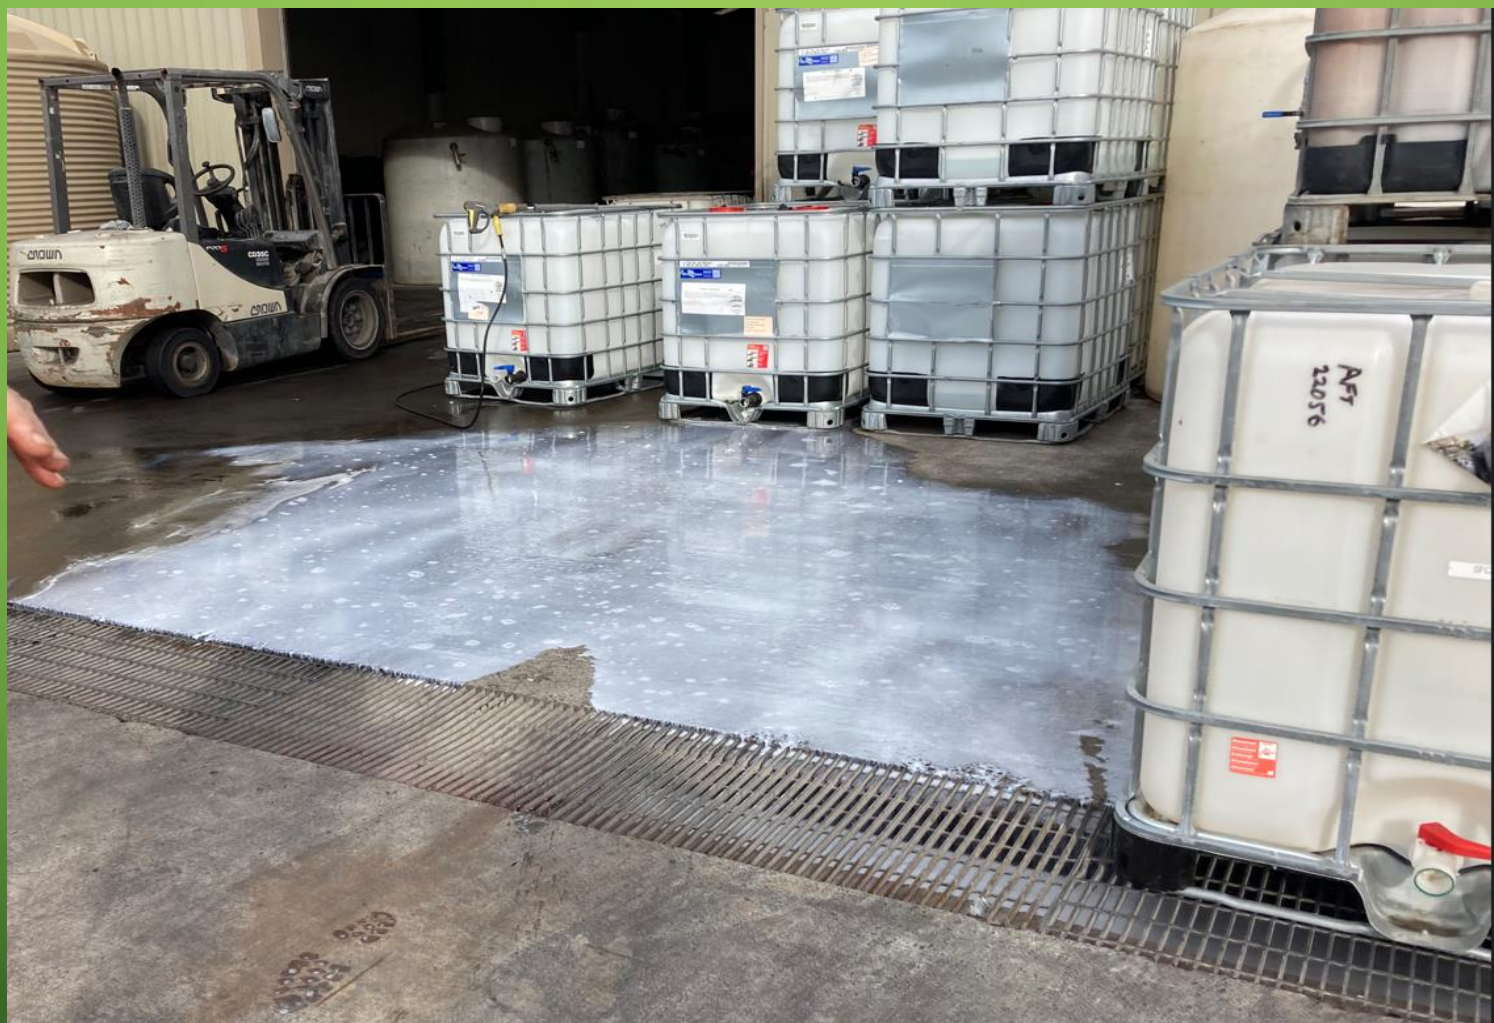
IBC's being cleaned and running into the trade waste system
