# Managing trade waste in a tourist hot spot

A CASE STUDY OF QUEENSTOWN, NEW ZEALAND

# 5-star hotel case study

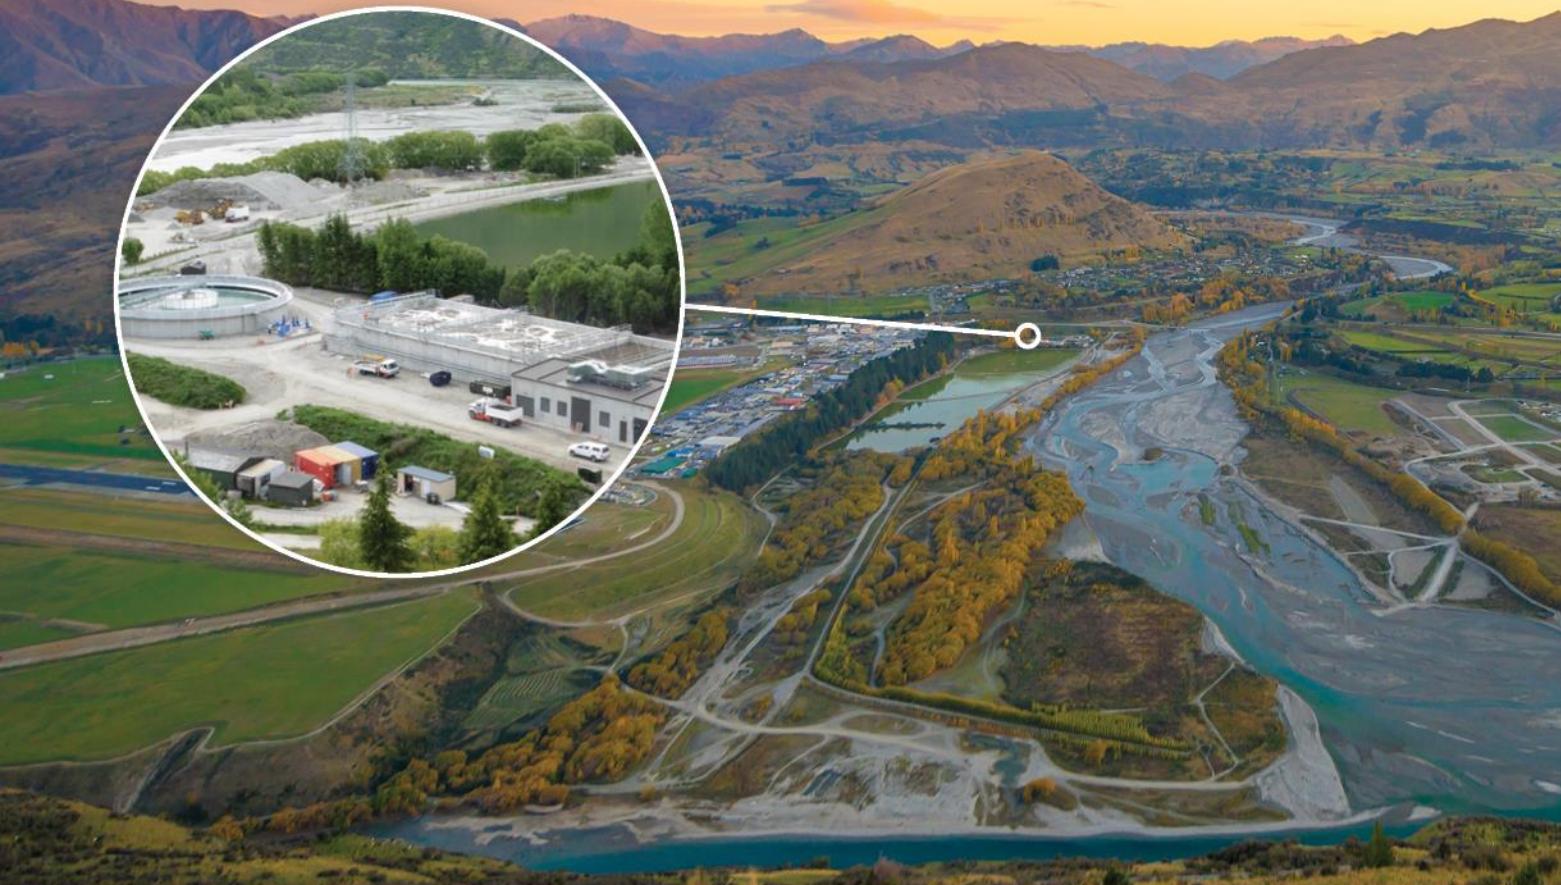
# Shotover Wastewater Treatment Plant

The Shotover Wastewater Treatment Plant is located near the delta of the Kimi-Akau Shotover River.

Upgraded in 2015 due to population growth and non-compliant effluent discharge.

The upgraded plant is designed to treat an average daily flow of 9,960 m<sup>3</sup>/day.

The typical flow is split with 63% sent to the new activated sludge plant and 37% through the existing pond system.

Further upgrades are underway and include construction of another replica activated sludge plant and clarifier, and the ponds are being decommissioned.

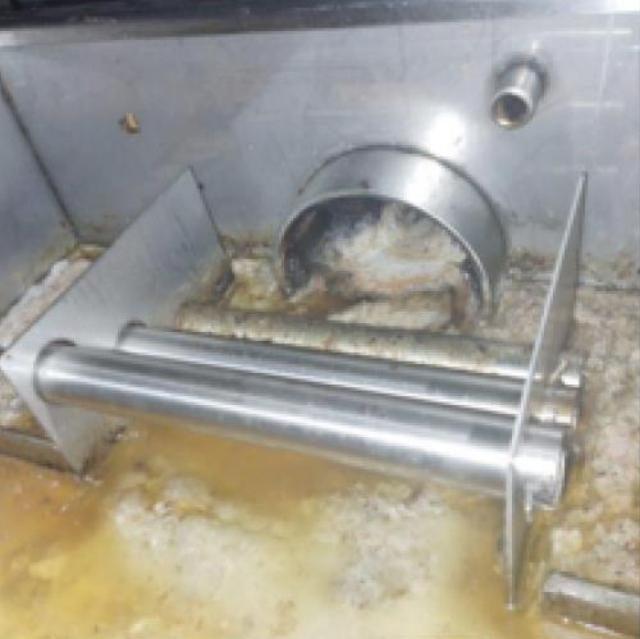
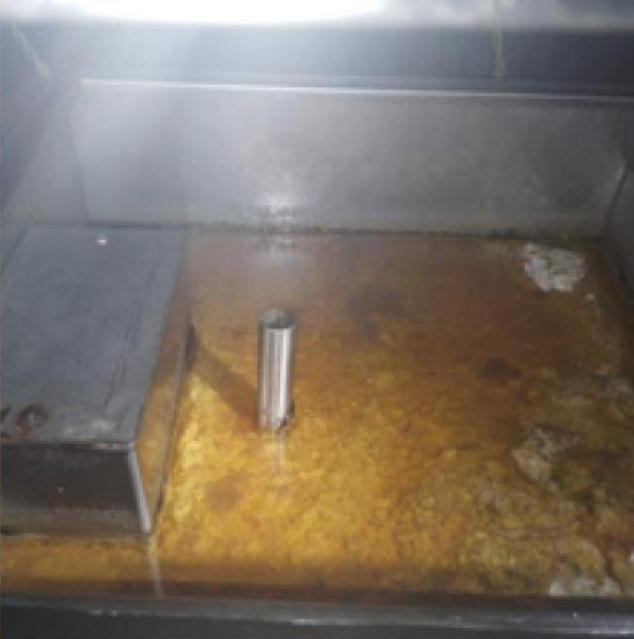
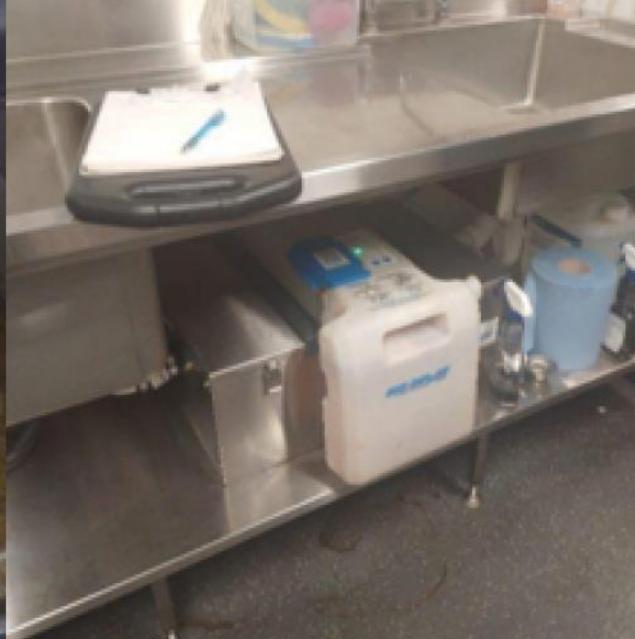
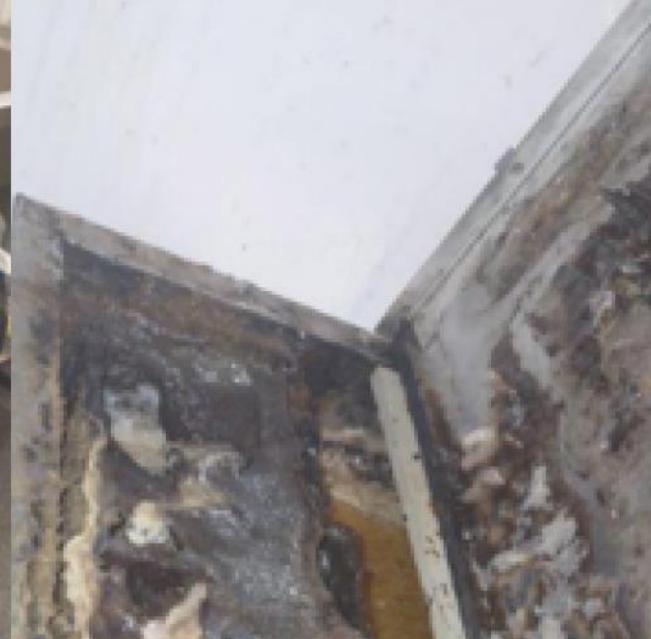
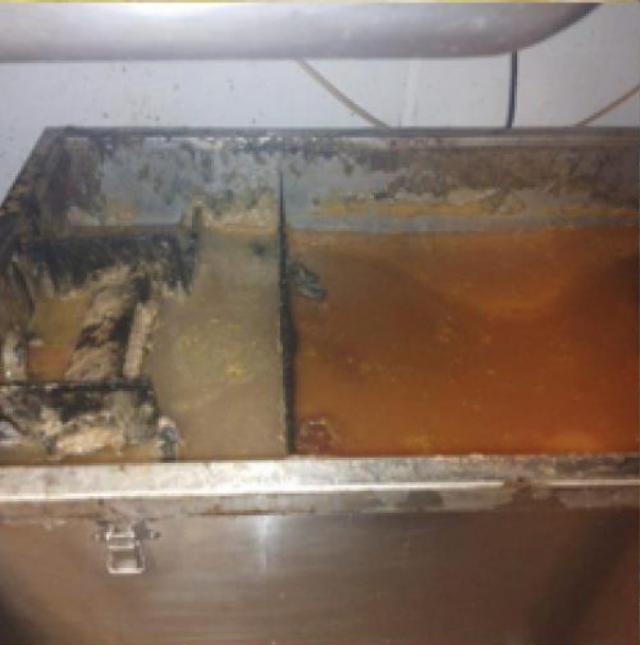
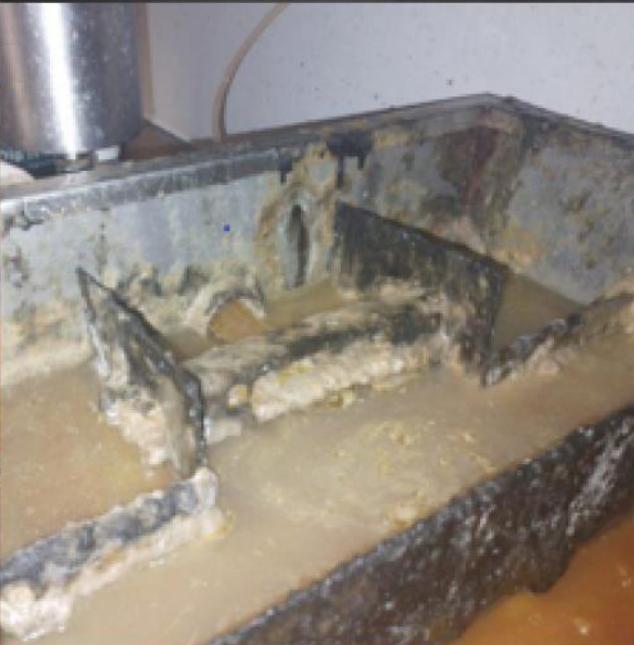
- > 7 grease traps are in use by the restaurants (4 Big Dippers and 3 Converters)
- > A daily cleaning schedule is undertaken.
- > However, hotel staff responsible for cleaning the traps haven't done so properly, resulting in very fatty traps.

Unfortunately, current testing shows significantly higher oil and grease results than permitted by QLDC's 3 Waters Bylaw.

GENERAL TESTING		
CBOD5 (as O <sub>2</sub> )	mg/L	2,700
Oil and grease	mg/L	18,000
pH (at room temp c. 20 °C)	pH unit	5.55

QLDC's Trade Waste team continues to work with this hotel and grease trap specialists in the district to improve the hotel's wastewater quality. Suggestions to improve wastewater quality on site include:

Building a new  
passive trap

Replacing all grease  
traps that may not be  
working properly

Adding a requirement for a  
professional company to clean  
the grease traps

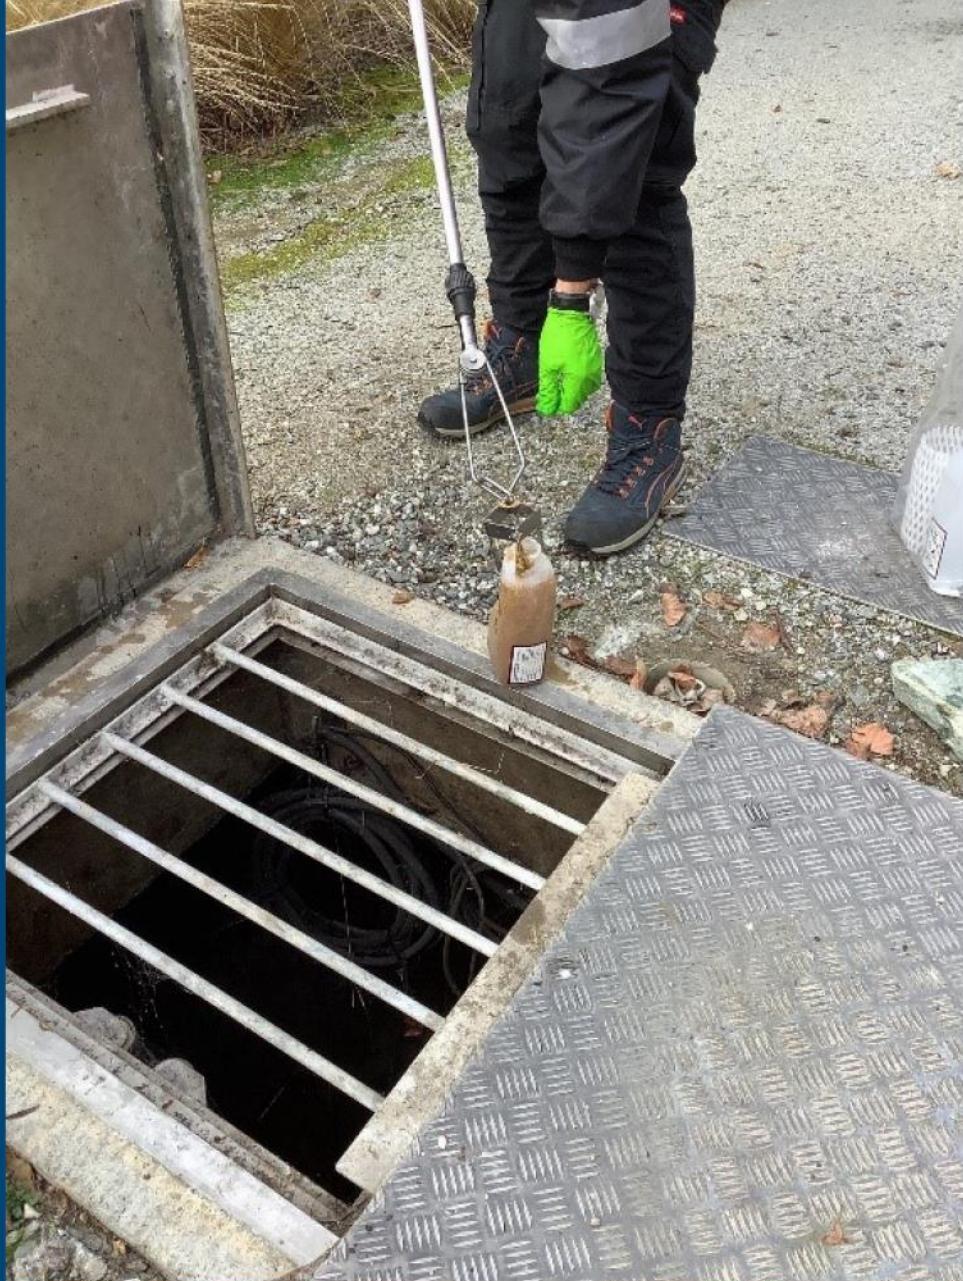
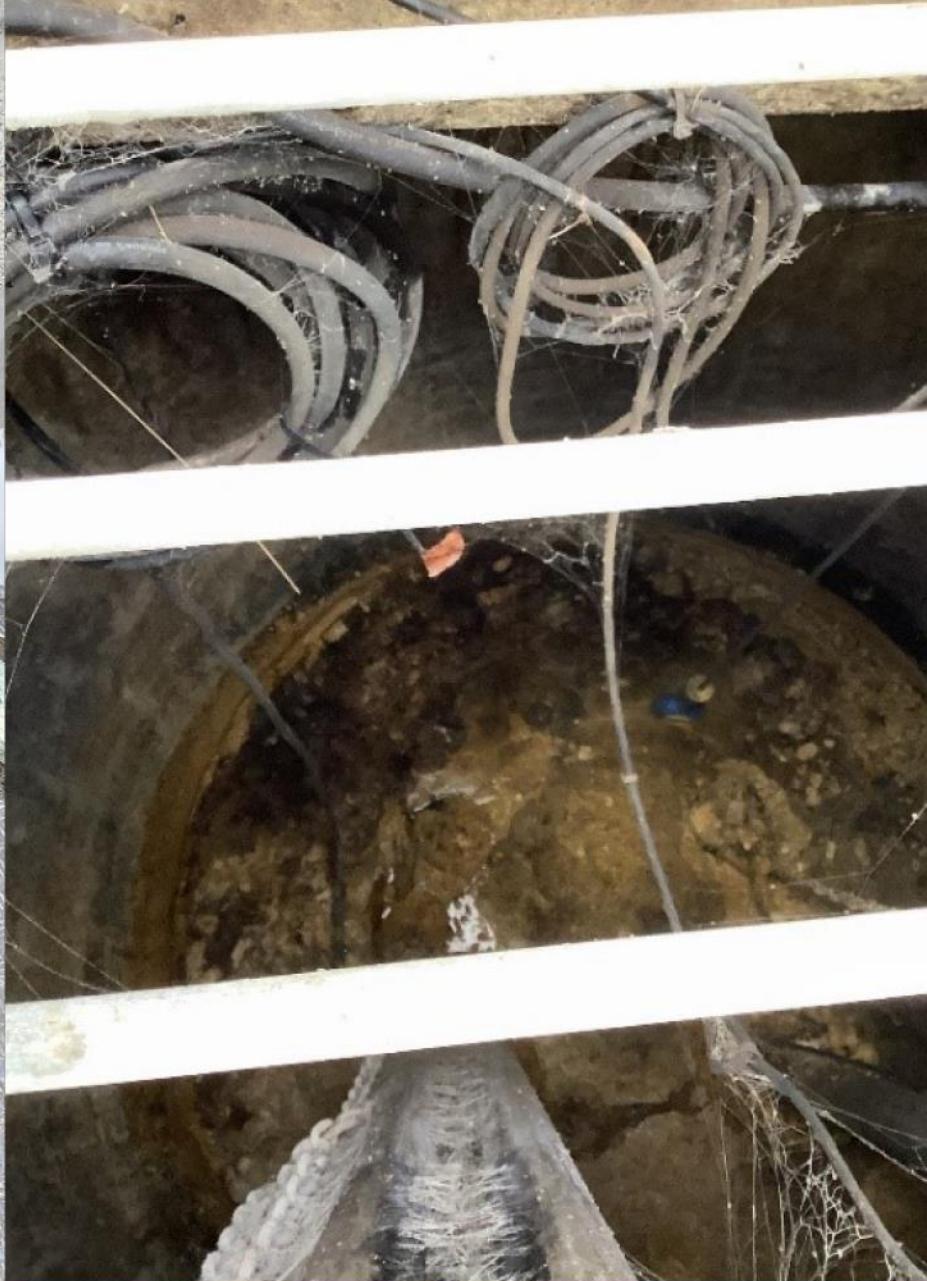
All wastewater from this hotel is sent to an interceptor tank close to Lake Whakatipu

- The tank is sampled every three months to monitor quality
- The wastewater pipe downstream of the hotel was recently re-lined.
- QLDC is required to reduce FOG going through the pipe as part of the warranty of the re-line.
